A/C - COOLANT LINES REPAIR AND REPLACE

SUV's MINI VANS REPAIR OR REPLACE FRONT AND REAR A/C / COOLANT LINES

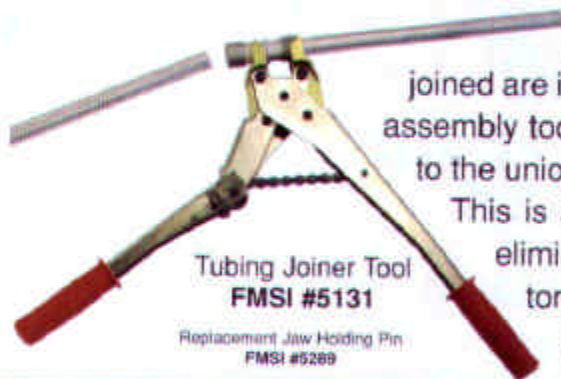
Tubing Joiner Tool
FMSI #5131

During assembly of a connection, the tubes to be joined are inserted into a union, up to an internal stop. The assembly tool (FMSI #5131) is then used to apply pressure to the union, which compresses to complete the connection. This is a quick and simple method of joining tubes that eliminates the fire hazards of brazing and proper torque concerns of threaded connections, while producing permanent leak-free connections.
